## Some Observations of Solder Joint Failure under Tensile-Compressive Stress

A paper for consideration for presentation at the  
ASME Electronic Packaging Conference,  
September 29 - October 2, 1993,  
Holiday Inn Arena Hotel, Binghamton, NY USA.

J.W. Winslow, Jet Propulsion Laboratory of the  
California Institute of Technology, Pasadena, CA

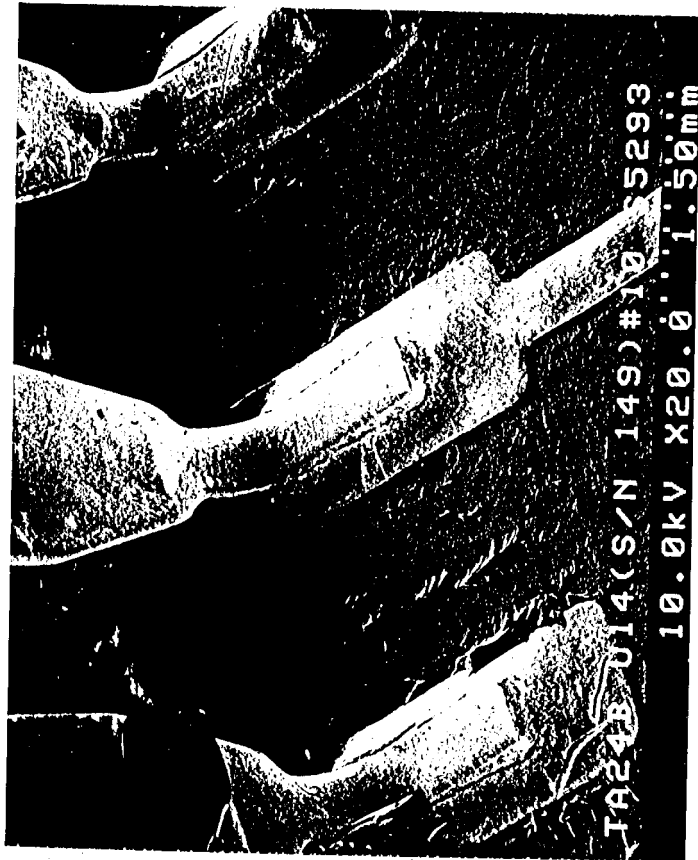
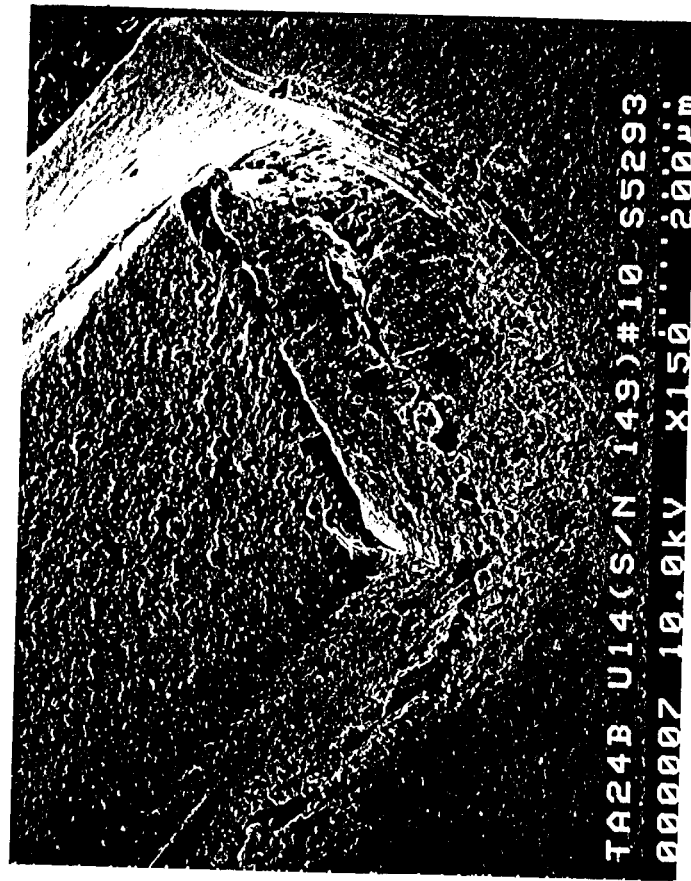
# FIG 5

We have noted in the past that solder joints in the gull-wing configuration, when thermal cycled, show surface cracks in the solder that first appear around the heel of the joint. Then, as thermal cycling continues, the cracks propagate along both sides of the lead foot until they reach the toe area. Then, the lead separates from the solder pad, as shown in Fig. 5.

SEM Photos - DIP leads at about 205  
thermal cycles after first pin failure.

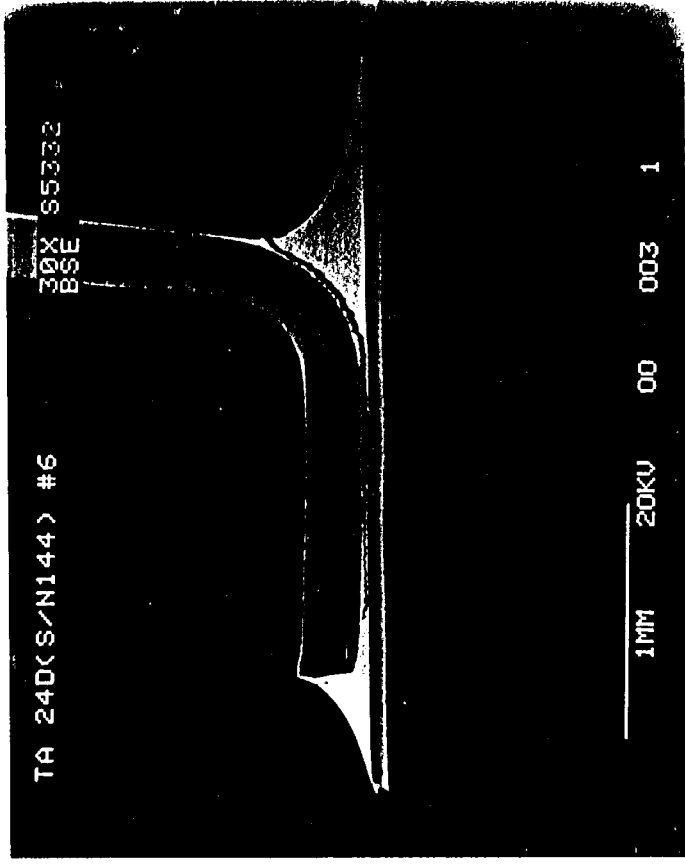
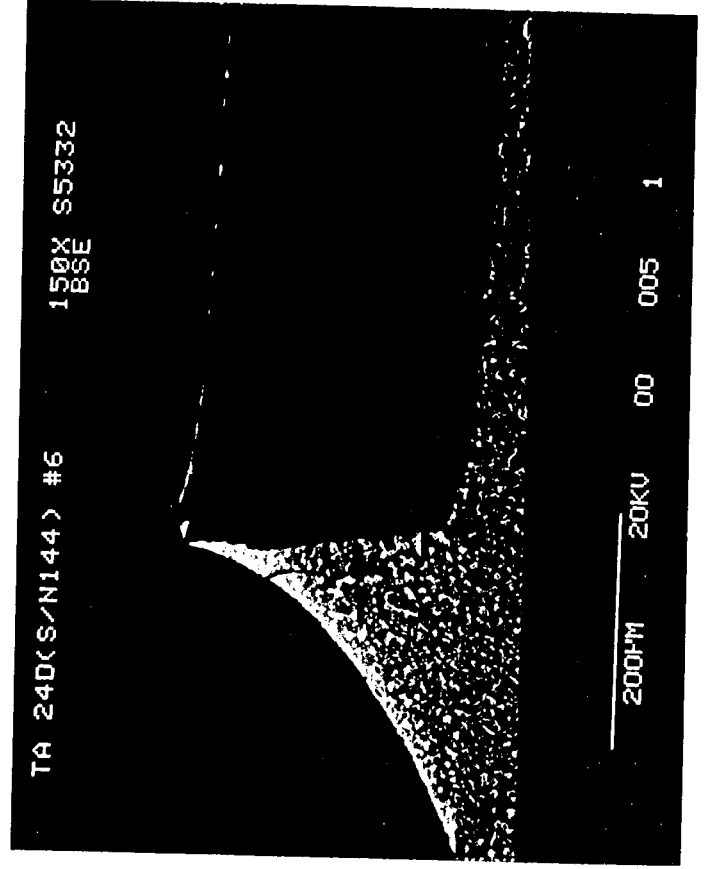
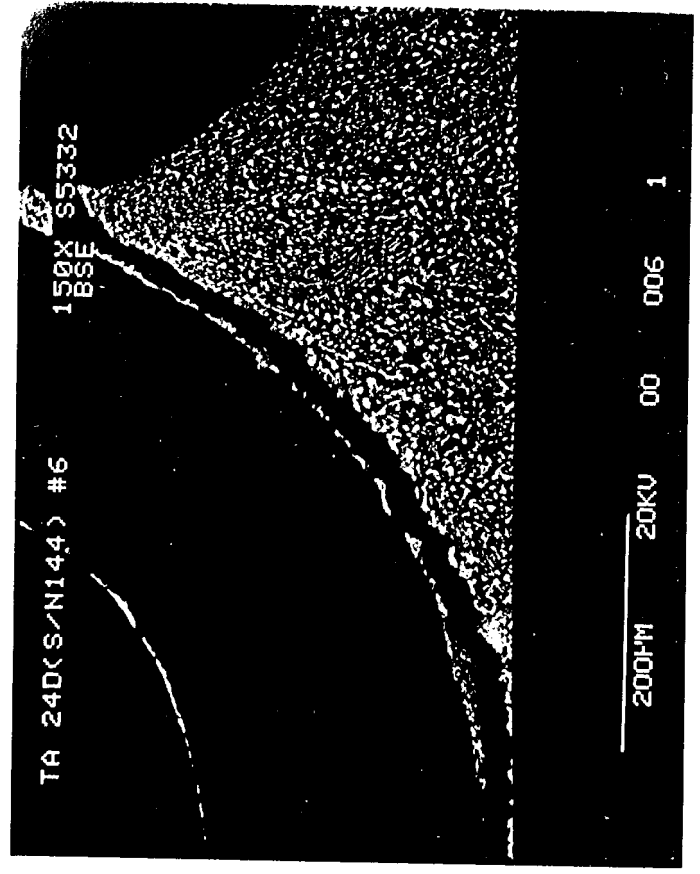
# FIG 7

Figures 6 & 7 show scanning electron microscope (SEM) photos of cross sections of two leads (Nos 6 & 9) of one of our gull-wing mounted DIPs, taken some two cycles after failure as defined by our event detector criteria. We note that lead #9 has separated completely from its solder pad, while lead #6 (directly across the DIP from #9) has separated from its pad along most of the length of the foot from the heel toward the toe, but remains attached at the toe.

SEM Photos of x-sectioned lead #6,  
DIP SN 144, about 2 cycles after DIP  
failure. Photos after cycle #377; failure  
at cycle #375.
